## Asbestos and Lead Survey Report

Navarro Inn  
Mendocino, California

RGA Project No: C&C21262

November 23, 2009

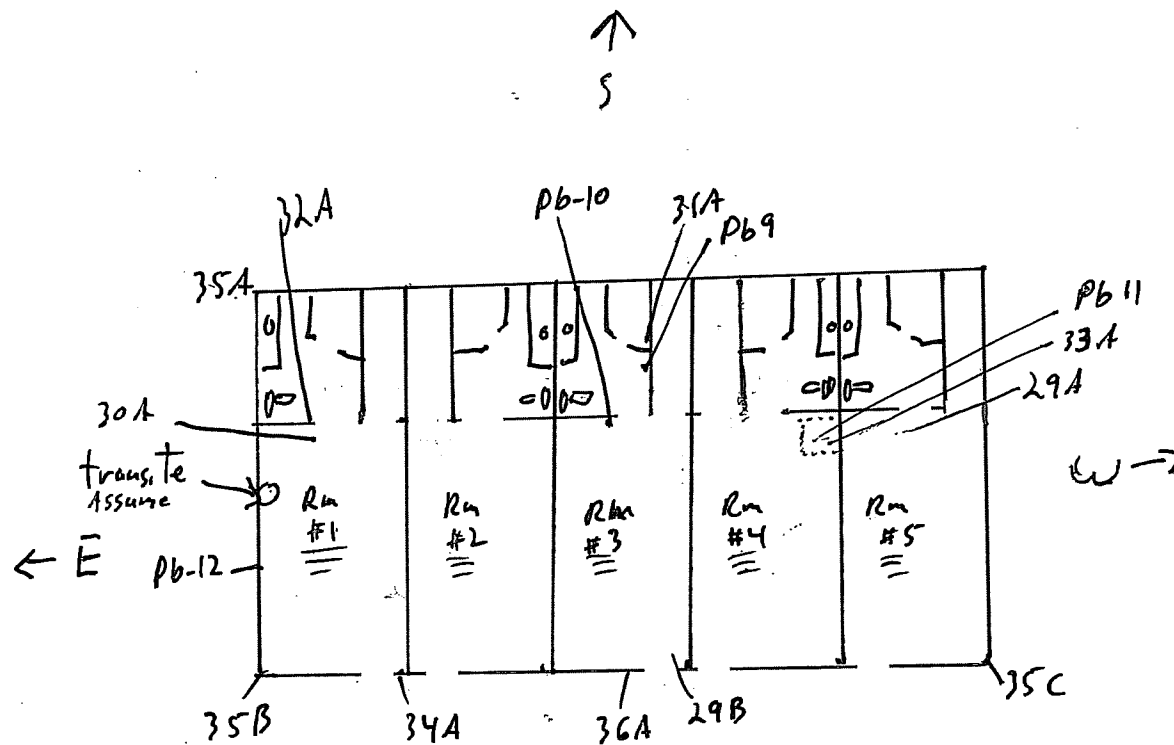
① DEMO PLAN - FIRST FLOOR  
SCALE: 1/4"=1'-0"

Note: Roof Penetration Plastic N  
+ Transite Assumed
