Wildlife Research Associates

11/09/09

**RE: Results of Bat Roost Habitat Assessment, Building Surveys and Mitigation Recommendations for Buildings at the Navarro-by-the-Sea Specific Plan Study Area
Navarro River Redwoods State Park
Mendocino County, California**

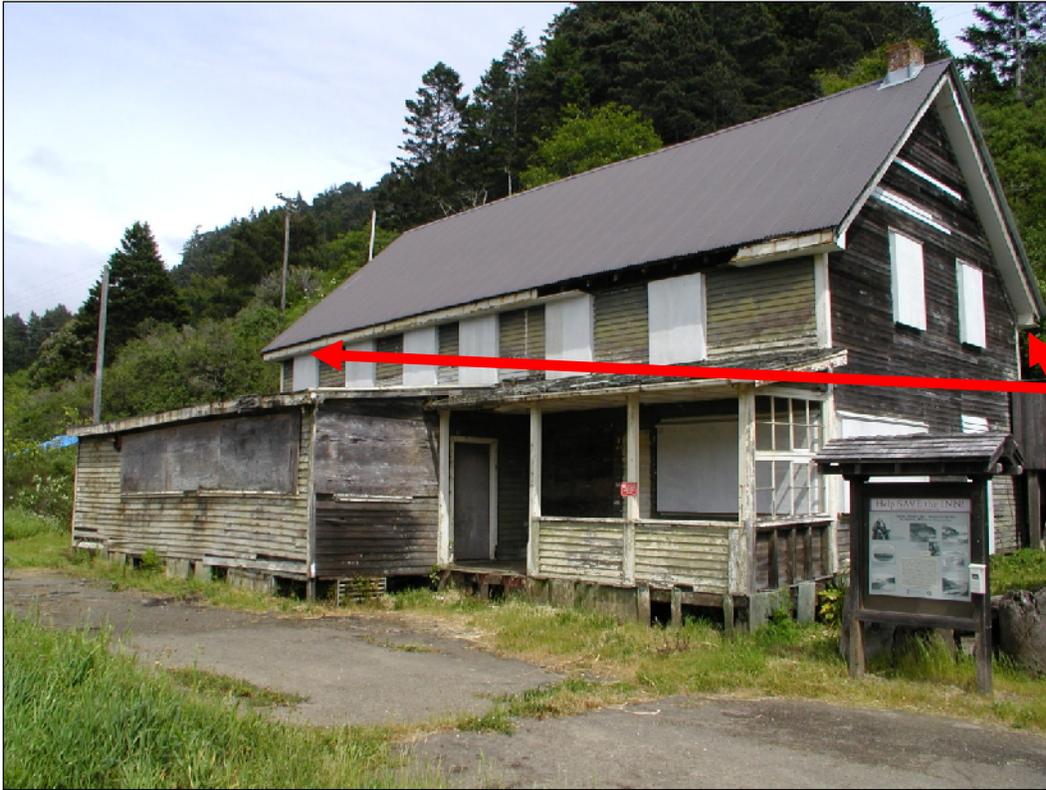
This 2-story building is constructed with wood shiplap exterior siding and a corrugated metal roof over composition roofing and skip-sheathing. The eaves are soffit, however portions of the soffit boards are missing from the front and other areas, leaving these spaces open, leading into the attic. Doors and windows are covered with plywood, except for two windows with bars on the east end of the building. Besides the openings into the roof, there are numerous gaps available around the structure for entry by bats, including behind warped plywood coverings and small window openings. The exterior materials are decaying and in poor condition. The interior space is decayed, with the front entry addition ceiling having almost completely disintegrated. Upstairs, gaps in the ceiling lead directly into the attic. Please see Figures 1-4.

Fig. 1. Above. Red arrows show soffit boards, to be removed to increase light and airflow into structure prior to and throughout construction. Maintaining unsuitable environmental conditions for bat roosting activity will substitute for conventional blockage and humane eviction process in this case.

- 4) After 2.a, above, remove soffit boards at start of construction and do not replace until conclusion of work. See Figures 1-4 for examples.
- 5) Prior to start of work each day, conduct a survey of the entire structure by a construction foreman trained by the qualified bat biologist, including the attic space, for bats that may have returned to the building overnight.

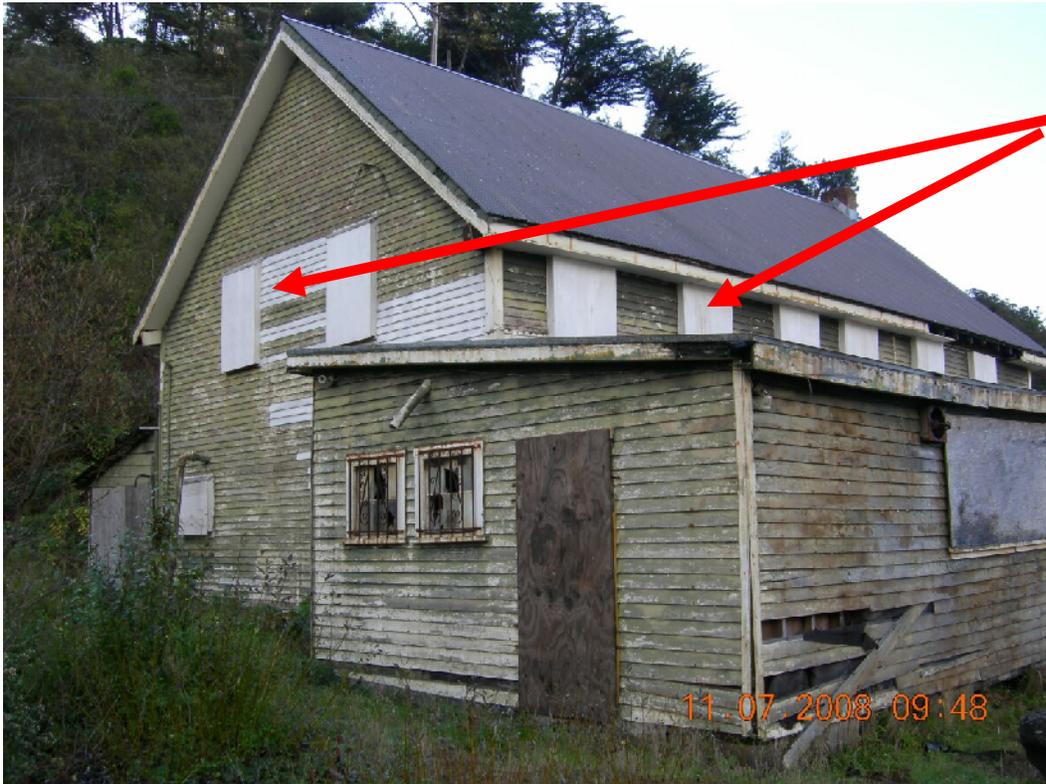
Fig. 2. Front addition, Navarro Inn. Arrows show soffit boards to be removed, as well as window coverings - all of which are to be removed - and windows left open - to increase light and airflow into structure before and throughout construction.

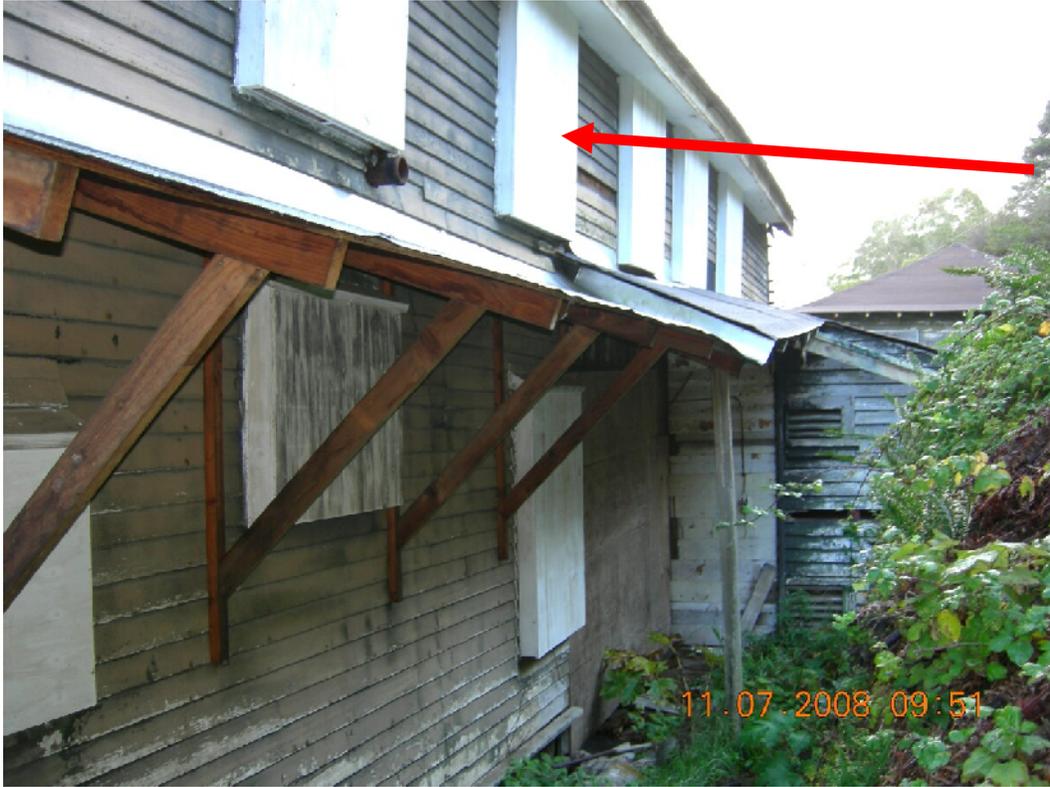
Figure 3. Rear of Inn, showing window covers, all of which are to be removed and windows left open before and throughout restoration.

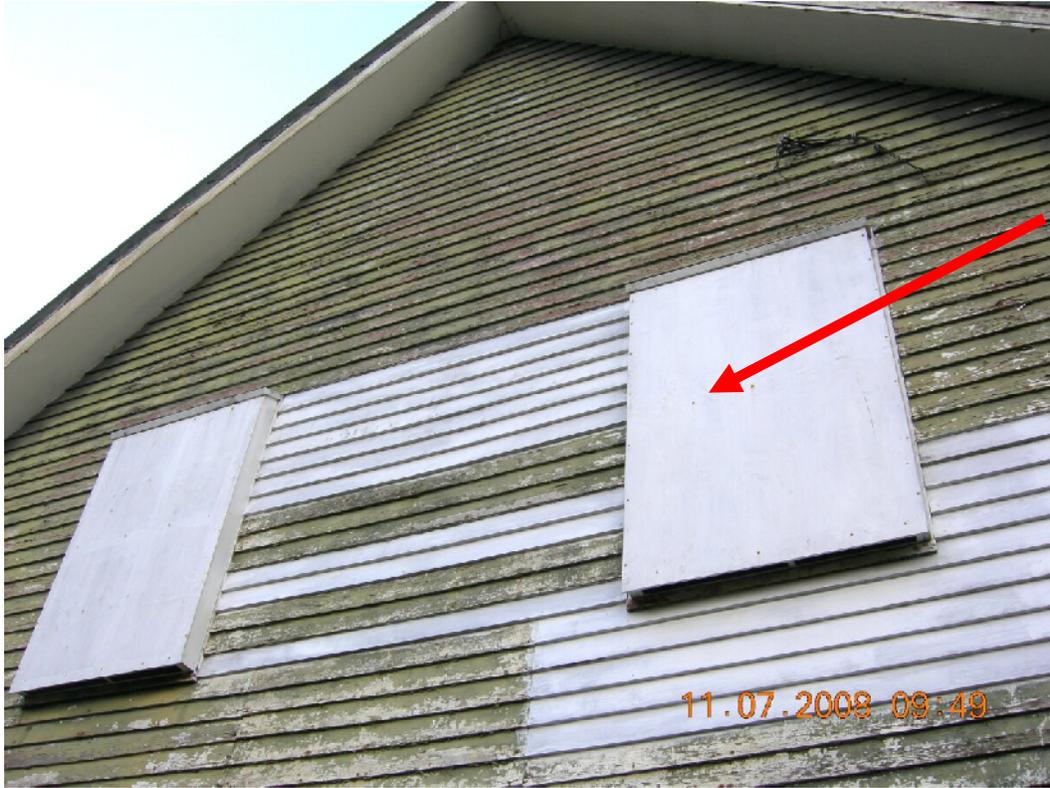
Figure 4. Remove window covers and open windows prior to and throughout construction.

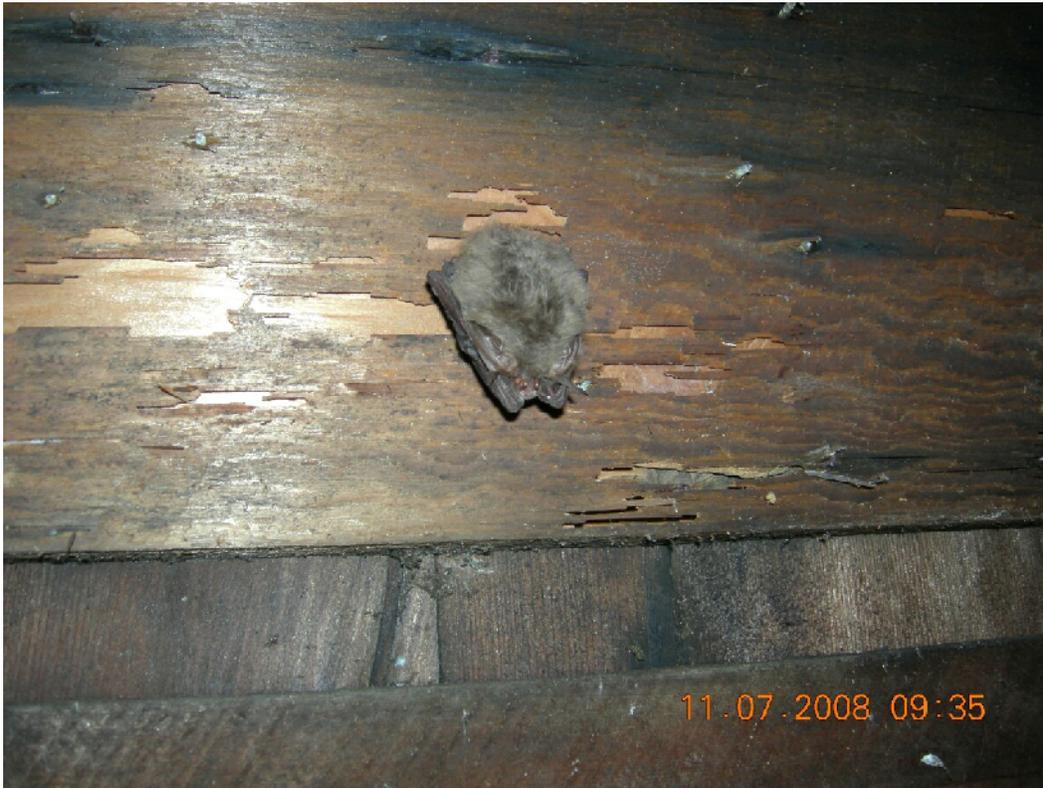
During the 2008 surveys, two *C. townsendii* were observed in the attic, roosting near the ridge on the ridge skip sheathing. Both bats were in torpor. Please see Figure 5. An additional *C. townsendii* was observed roosting from a ceiling joist in a lower floor room at the east end of the building, also in torpor. Fecal pellets consistent for the species were observed scattered in various locations throughout the building, however no large accumulations were noted in any room, closet, or even the attic. Extensive evidence of rodent activity was observed throughout the structure, including the attic.

Figure 5. One of two *C. townsendii* in attic of Inn.

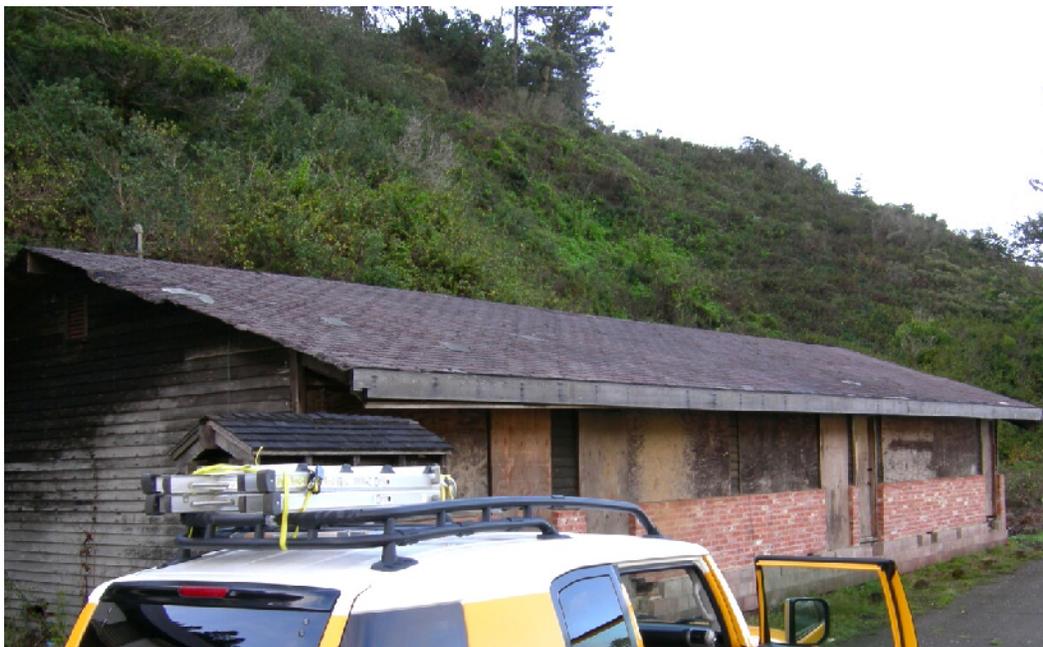
The single-story rectangular-shaped building is constructed with a ½-height brick façade at the front, and wood shiplap siding exterior with a composition shingle roof. The building contains five small rooms. The doors were covered by plywood which was removed for these surveys. Several openings lead into the attic space, including the gable vents and eaves. See Figures 6-9.

Figure 6. Motel building.

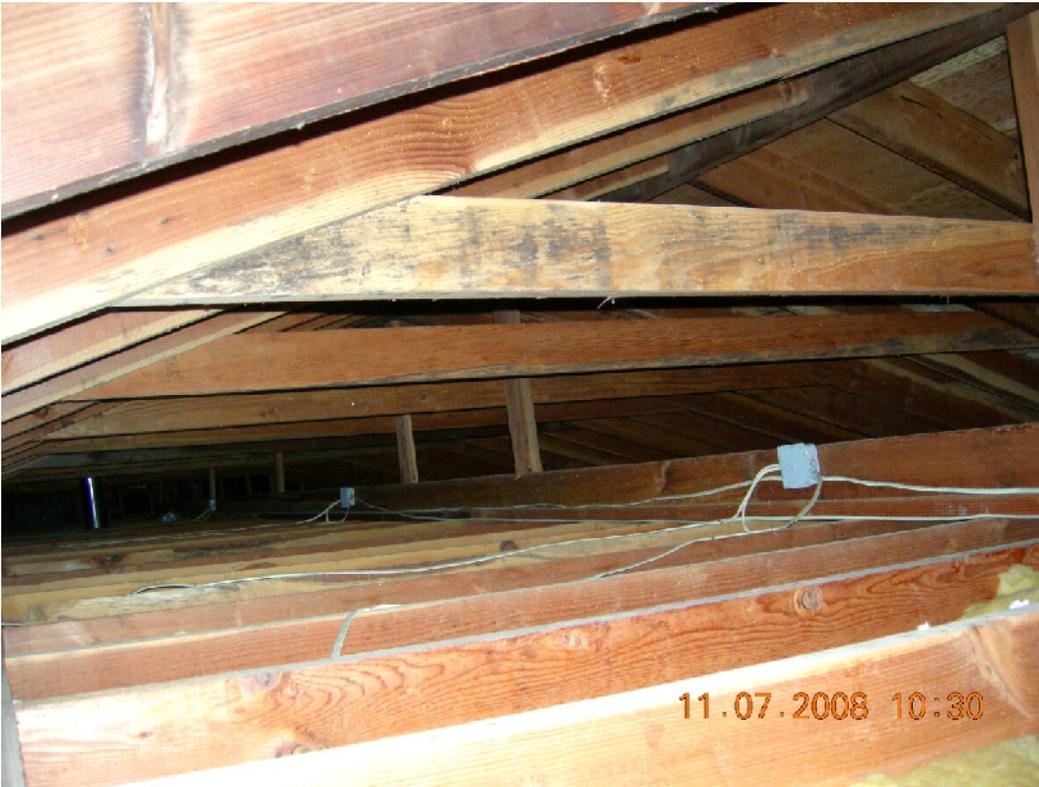
Figure 7. Motel building attic.

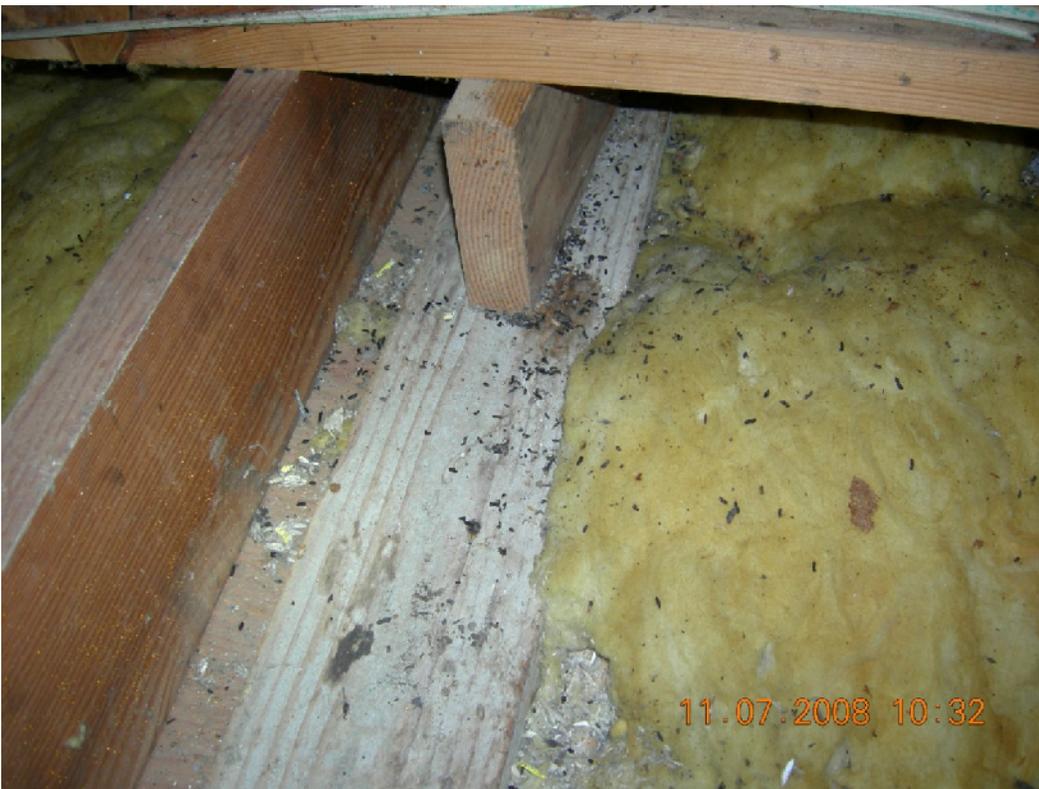
The Motel provides suitable day and/or night roosting habitat for bats. Evidence of bat roosting activity, most probably by *Myotis* sp., based on the fecal pellet accumulations, was observed in several of the rooms and in the attic space. Small piles of fecal pellets suggestive of *C. townsendii* were observed beneath ceiling light fixtures in two rooms; however they had almost completely decayed, suggesting that they were very old. No live or dead bats were observed. Extensive evidence of rodent activity was observed throughout the structure, including the attic.

Figure 8. Bat fecals in Motel attic – probably *Myotis* sp.

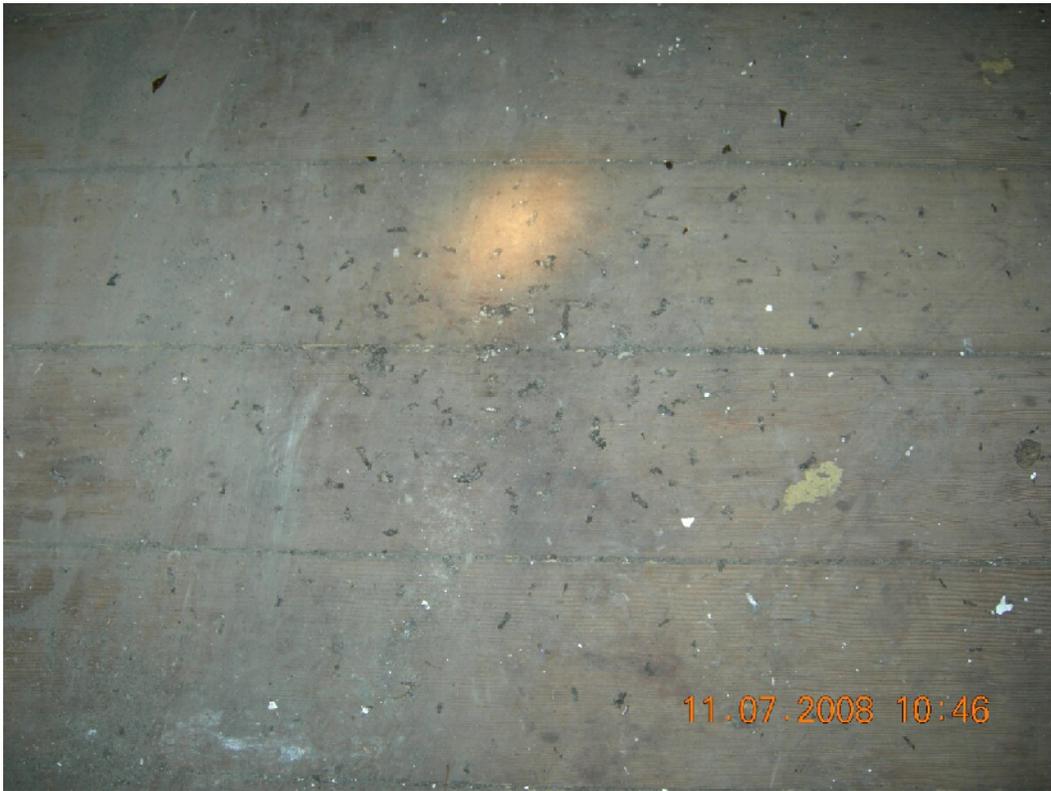
Figure 9. Bat fecals in Motel rooms – probably *Myotis* sp.

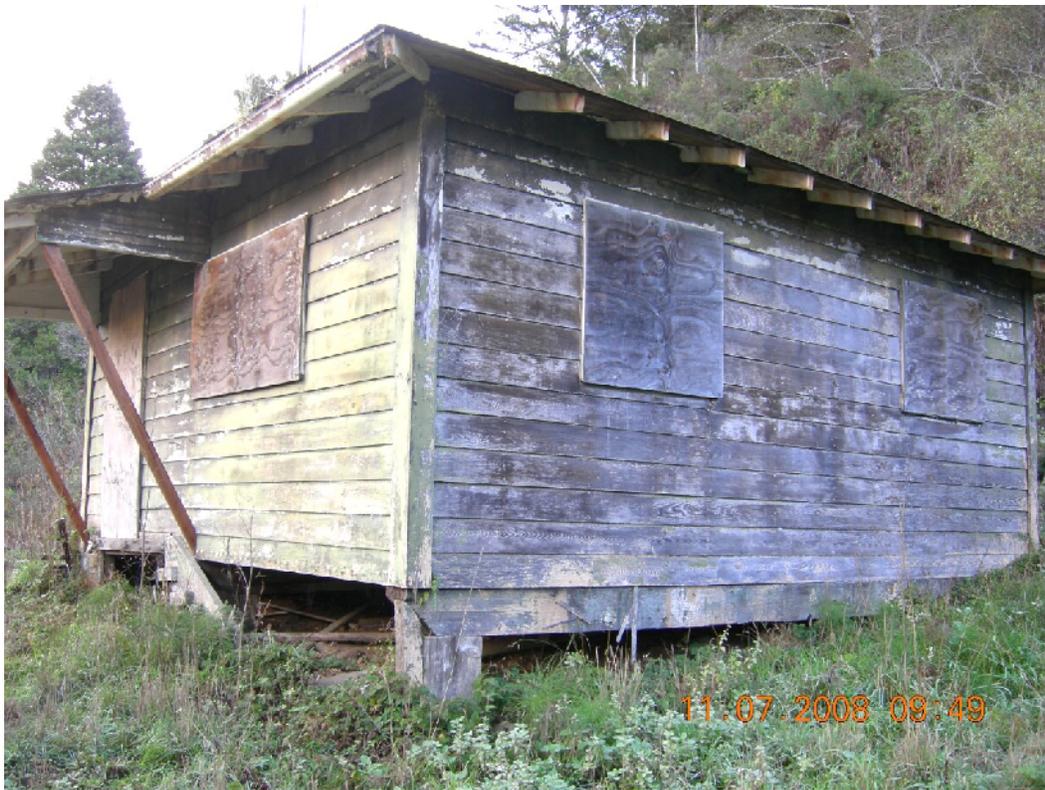
These small, square-shaped single-story buildings are located just east of the Inn, and are in advanced states of decay and partial disassembly inside. They are covered with wood shiplap siding and composition roofing over skip sheathing. Surrounding vegetation has grown up against the structures to a height of around 3-4 feet. There are numerous openings into the buildings at the walls, door and window coverings, and eaves, as well as kitchen wall storage locker extensions, commonly called “California Coolers”. See Figures 10-12.

Figure 10. West cabin.

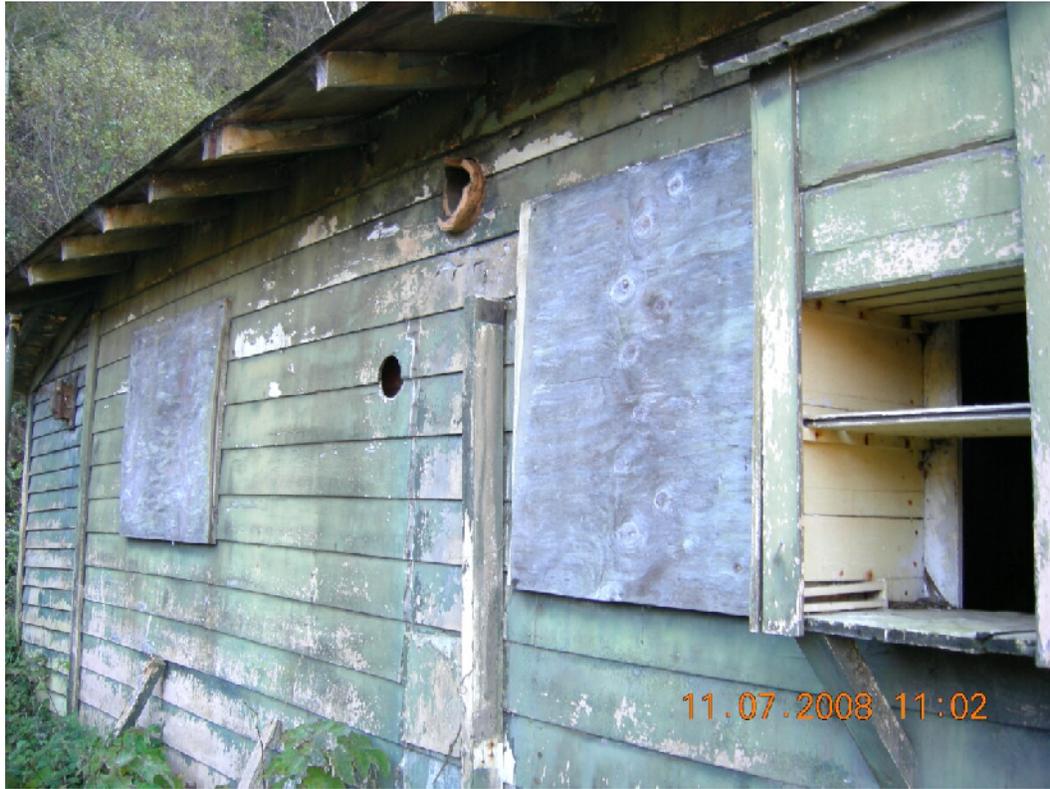
Figure 11.
Openings into
West cabin.

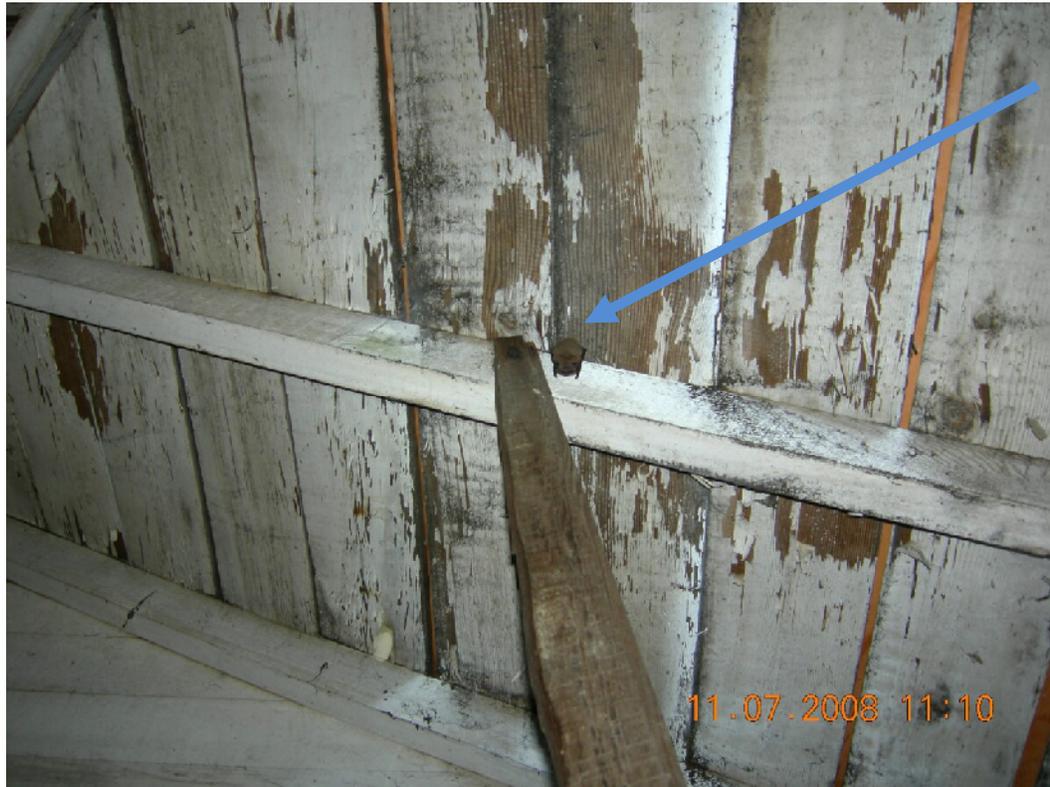
Conditions appeared to be unchanged between surveys, except that surrounding vegetation had grown taller around the building exteriors. One *C. townsendii* was observed roosting in the rafters of the western Cottage, which flew immediately out of the structure. The eastern Cottage was empty, and no large bat fecal pellet accumulations were observed in either structure.

Figure 12. *C. townsendii* in
West cabin.

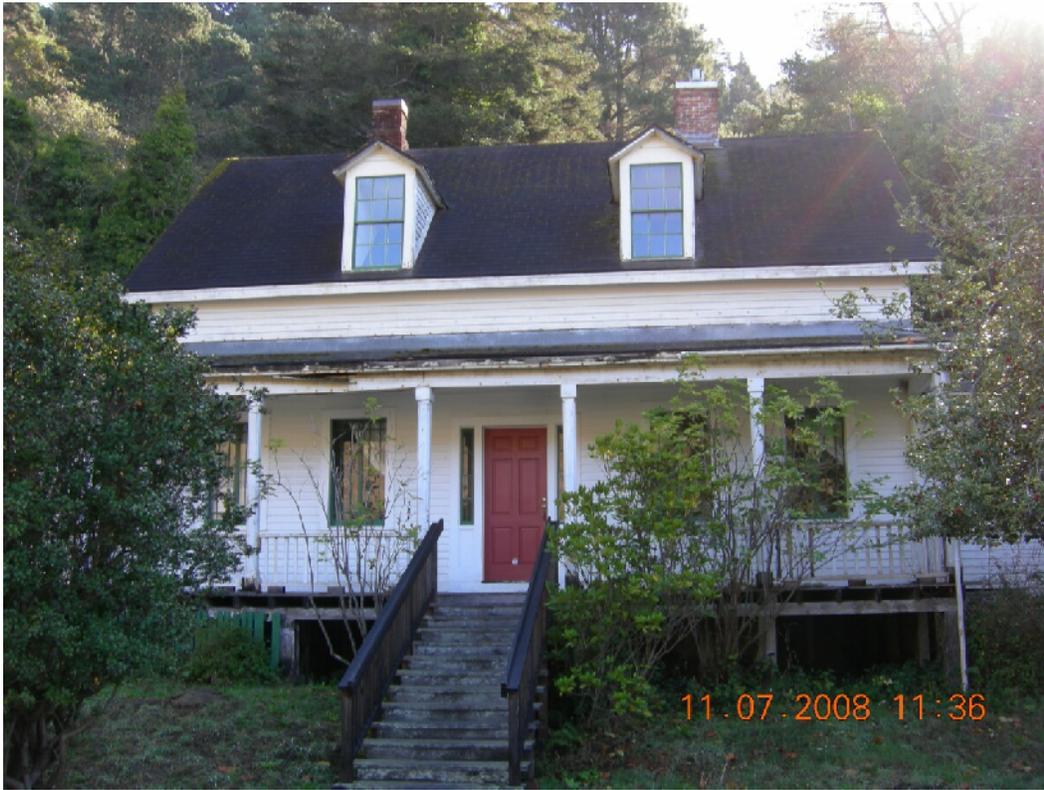
The Mill House is a two-story, wood-sided residential structure, located furthest to the east of the complex of buildings. The farmhouse-style structure includes two dormers atop a steep, composition-shingle roof over butt-fitted board underlayment. There are two small, single-story wings that extend of the east and west ends. Siding is wood shiplap, and eaves are soffited. Doors and windows are uncovered by plywood because this building provides office space for NSCR and CDPR staff, as well as interpretive areas for visitors. A front porch with ceiling board covering the ceiling joists extends partway across the front, and is in fairly advance stages of decay. There are numerous openings into this structure, including the eaves, porch roof, and potentially chimney flashing and dormer roof joints. See Figures 13-16.

Figure 13. Mill House. Numerous openings available to bats at eaves, possibly dormers, vents.

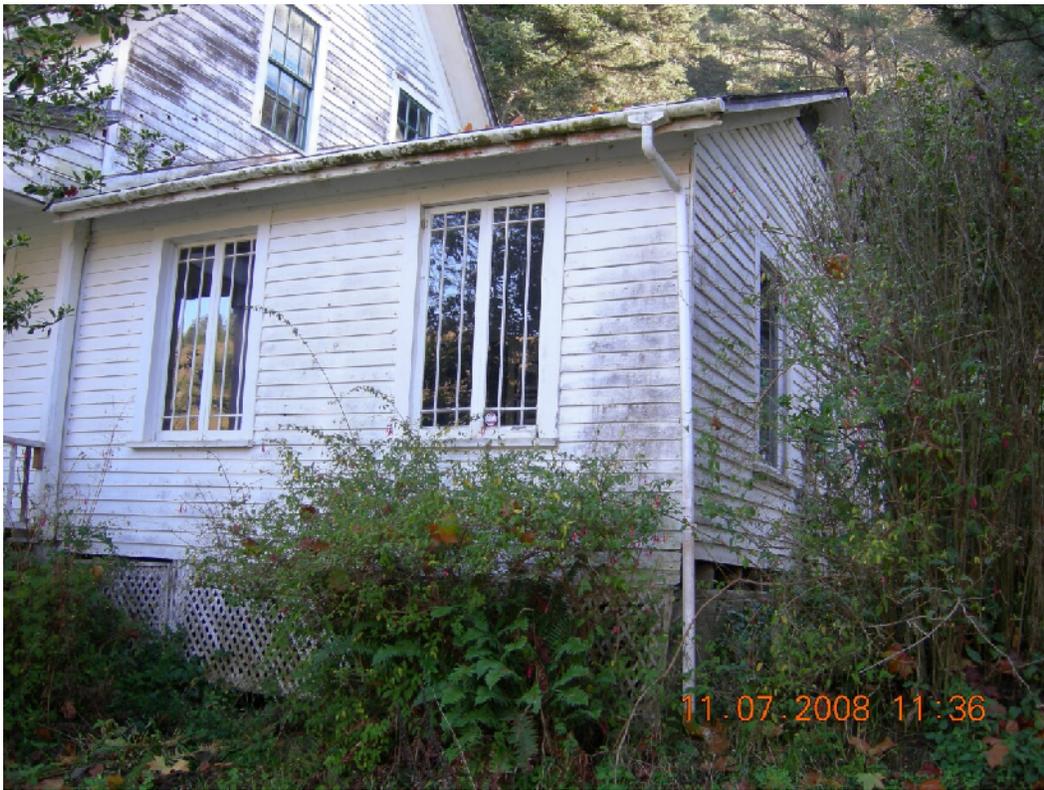
Figure 14. West wing of Mill House.

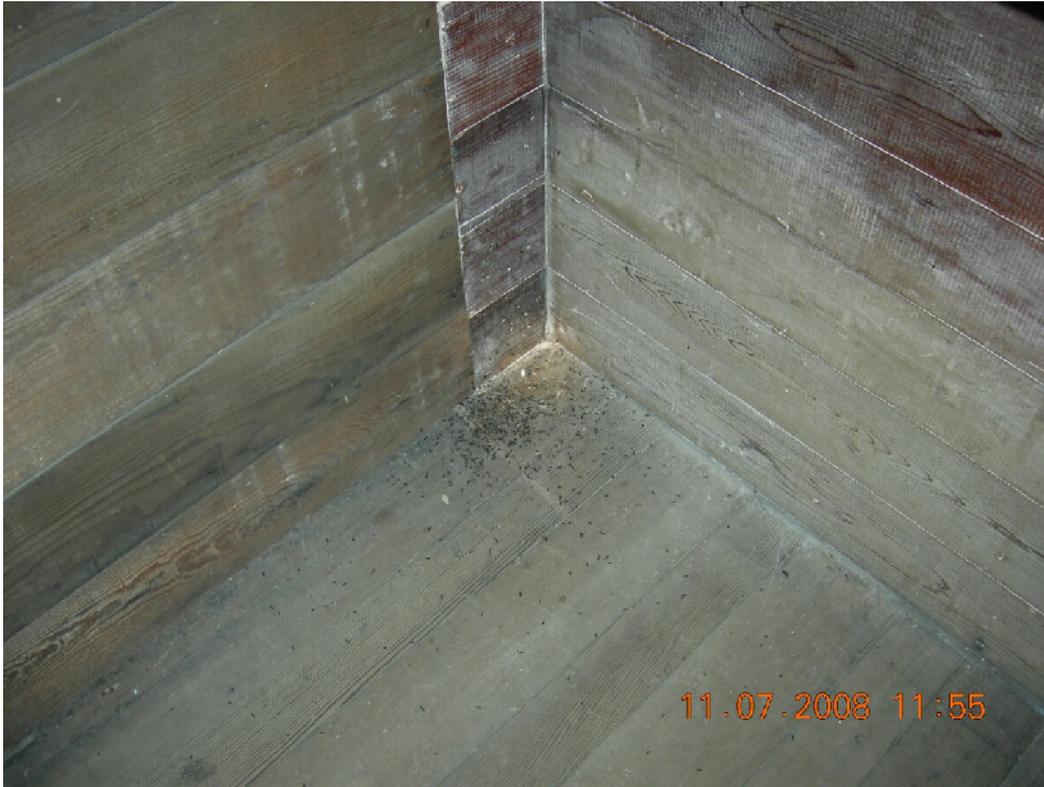
The Mill House provides suitable day and night roosting habitat for bats. Evidence of bat roosting activity was observed in the downstairs rooms and attic spaces above each single-story wing. Accumulations of fecal matter in the corners of the rooms downstairs and upstairs, and large accumulations of fecal matter in the attic were observed. The majority of fecal matter was consistent with *Myotis* species. One *Myotis* sp. was observed in the upstairs attic roosting in a crevice formed by the junction of the roof underlayment and brick surface of the chimney. The bat moved into a small crevice before it was possible to capture the bat for examination, but appeared to be *M. californicus*; it was definitely not *M. yumanensis*, based on pelage and skin color. One desiccated *M. californicus* was found laying on the insulation of the attic. Fecal matter consistent with *C. townsendii* was found in an upstairs closet in the office rooms mixed together with those consistent with *Myotis* species, indicating that at least some amount of day and/or night-roosting activity by the former species had occurred at some time in this structure. No *C. townsendii* individuals or insect prey remains were observed in the structure. Extensive evidence of rodent activity was observed throughout the structure, including the attic, where about 15 or more dead deer mice (presumably deer mice (*Peromyscus maniculatus*)) were observed, many freshly dead.

Figure 15. Bat fecals in Mill House upstairs closet – probably *Myotis* sp.

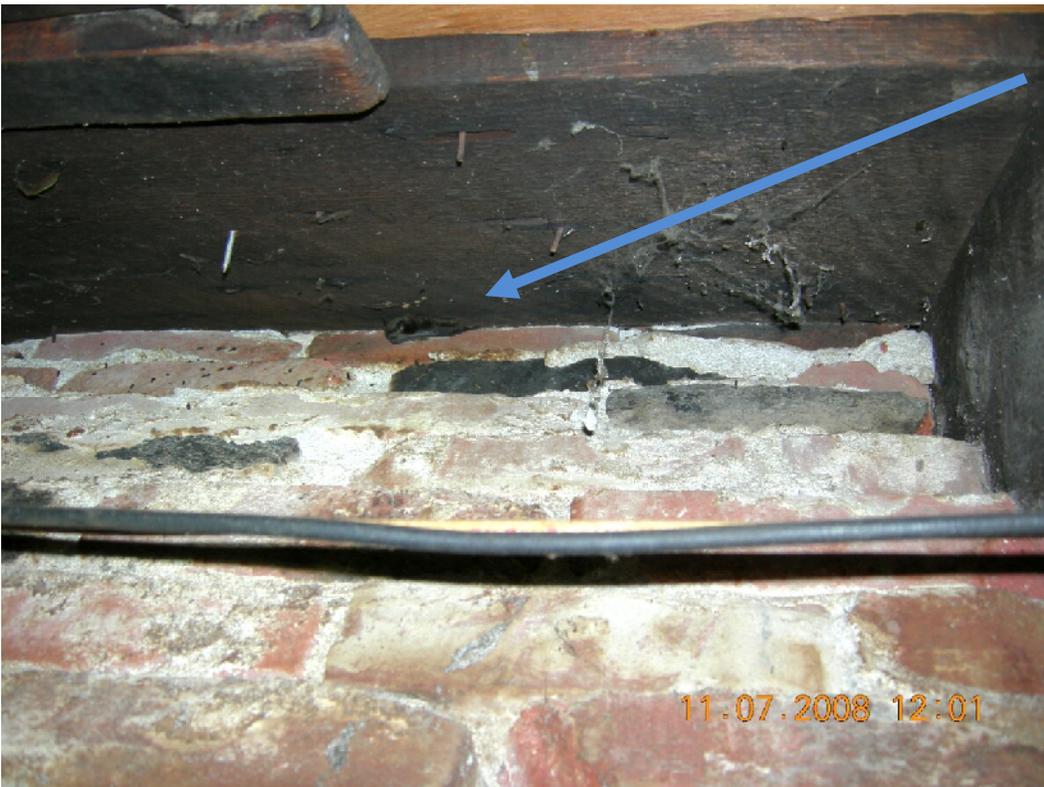
Figure 16. *Myotis* sp. in attic at chimney x roof corner.

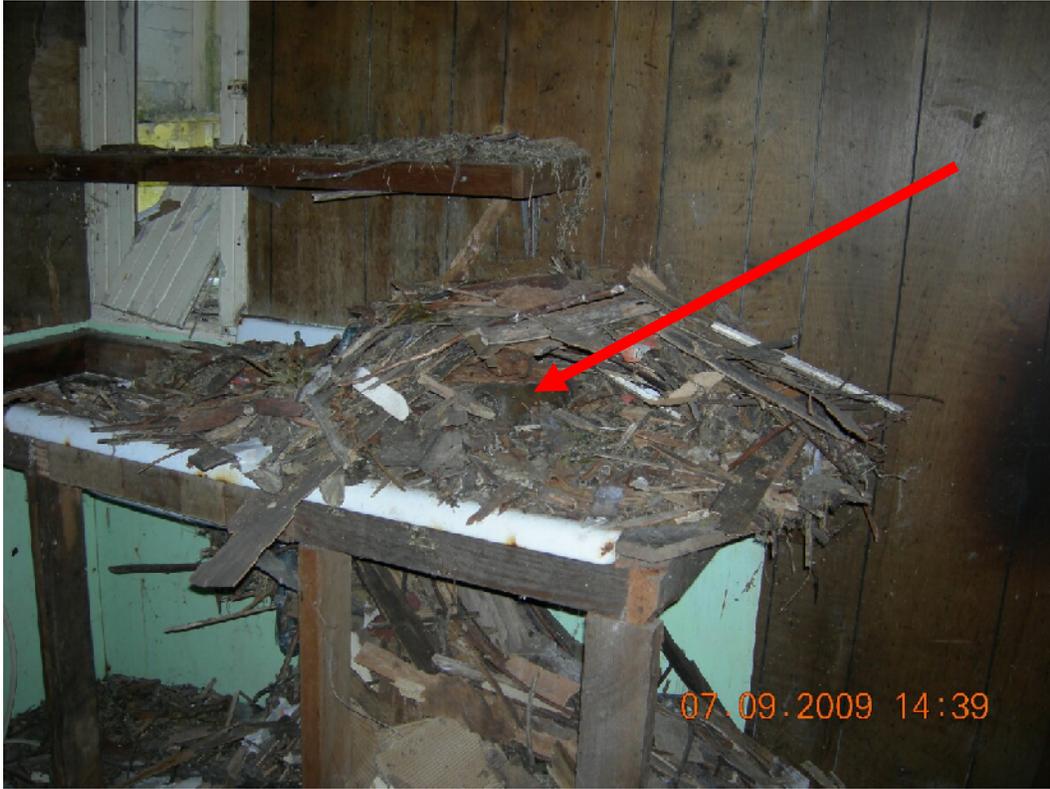
Figure 17.
Example of debris
in Cottage to be
removed.

Establish the Cottages located to the west of the Inn as dedicated *C. townsendii* day/night, dispersal/bachelor roosting habitat. After either conducting surveys to verify absence of bats, or conducting humane eviction (as in Mitigation 1.1, above) if bats are present, remove all debris from inside the buildings (Fig. 17), and make any necessary repairs to the roof, siding and structure. Remove the ceiling from the easternmost cottage, leaving rafters exposed (Fig. 18). Create new bat entry openings by modifying the exterior openings of the California Coolers to close the existing lower portions with plywood, and opening the top portions which are currently closed (Fig. 19). Conduct periodic vegetation clearing away from the structures, and implement an interpretive program that include use of signs that instructs visitors to stay away from the cabins because they provide habitat for a sensitive species. This interpretive program should be carefully designed to avoid attracting attention to the buildings.

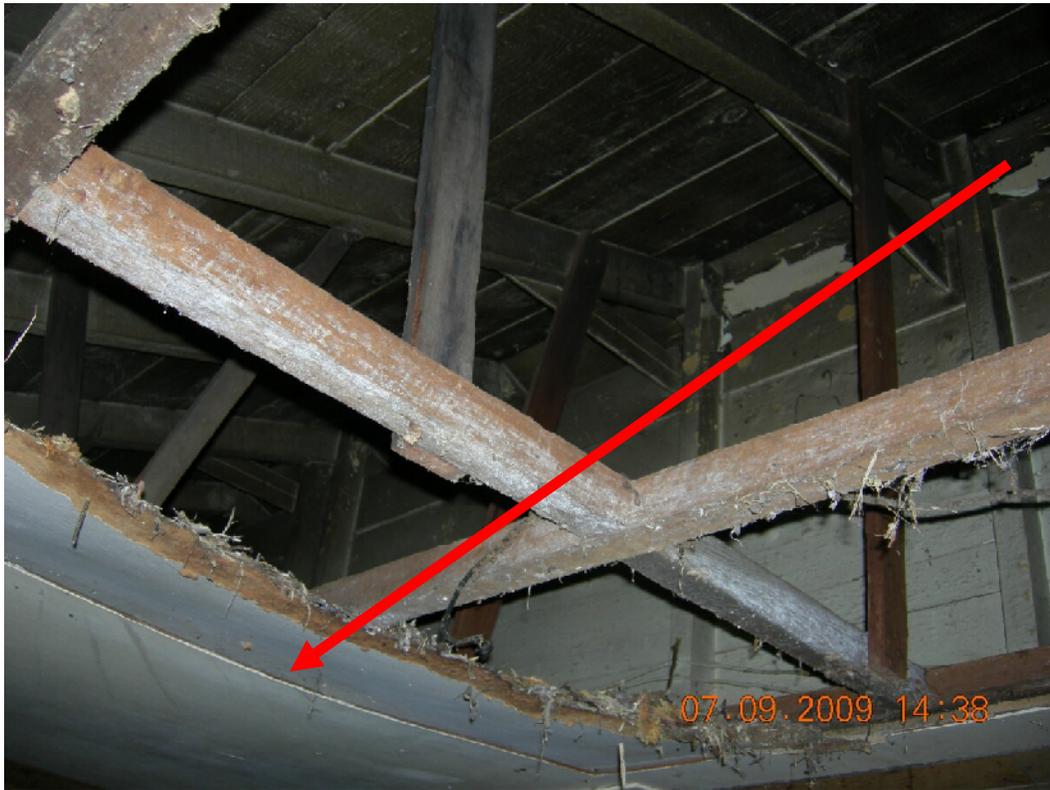
Figure 18.
Remove decayed
partial ceiling in
Cottage, leaving
rafters exposed.

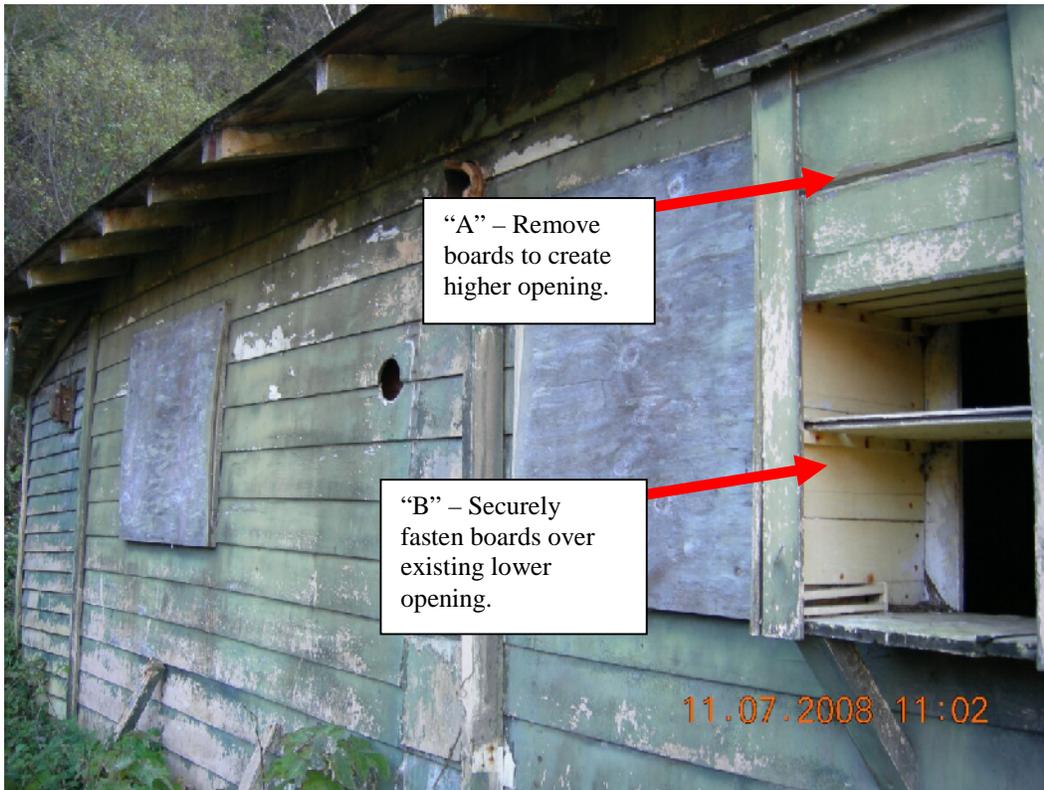
Figure 19. Remove boards from California Cooler section "A". Securely fasten plywood over section "B". Repeat at second cottage.
